TEST REPORT

Report No. : HL10267B/2024

Product Description: W3.8 Rope

Test Requested: Pulling test

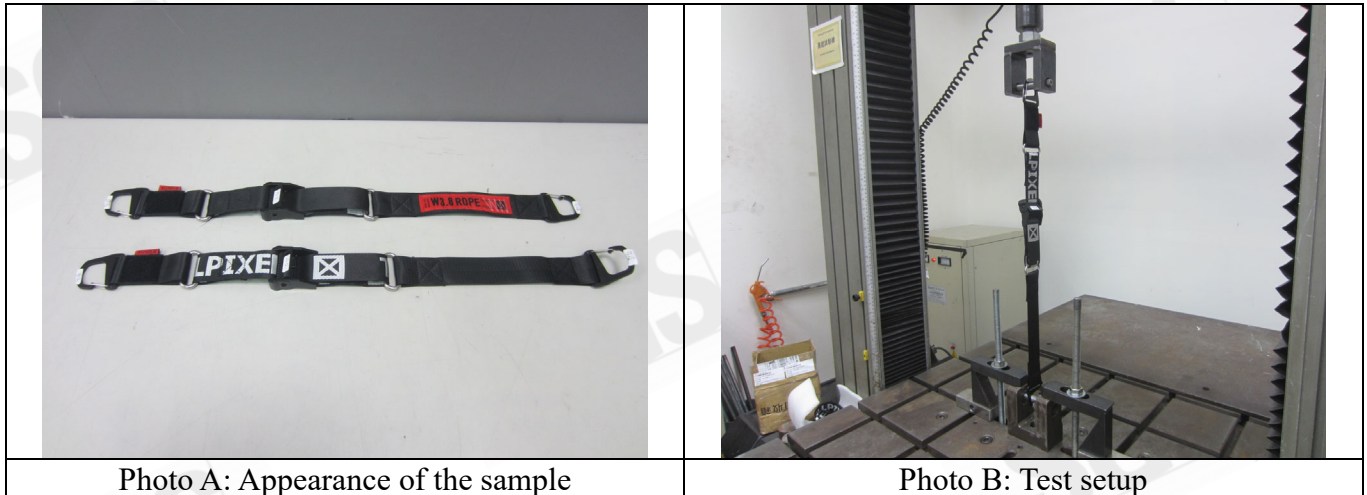
– Picture(s)–

- (a). Secure the sample on the testing machine.
- (b). Apply an increasing upward force to the sample until it is damaged or slipped.
- (c). Record the max. force and any findings.
- (d). Testing Machine: INSTRON 5581, Rate: 30 mm/min.

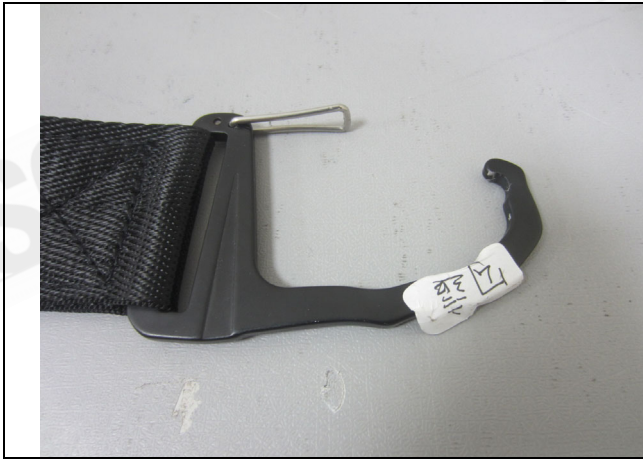
Photo C: After testing

Sample	Max. force (kgf)	Result
W3.8 Rope	287	The metal clip hook was deformed greatly after testing.
