## TEST REPORT

Report No. : HL10266B/2024

Product Description: W3.8 Rope

Test Requested: Pulling test

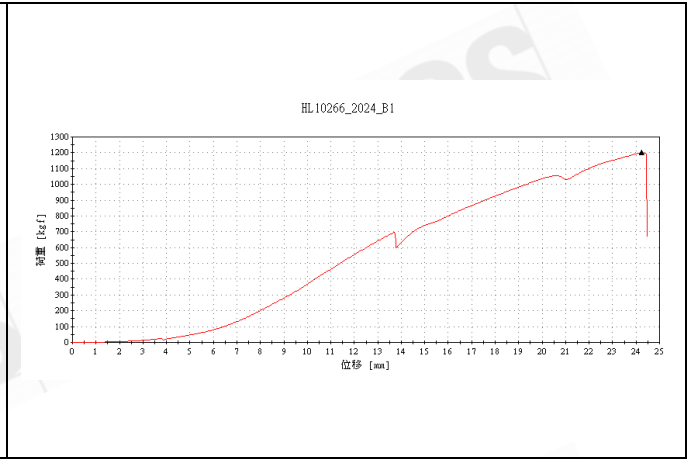
Photo D: Test curve

Sample	Max. force (kgf)	Result
W3.8 Rope	1200	The metal adjustment buckle was damaged after testing.
